Operating Experience Weekly Summary 97-09

February 21 through February 27, 1997

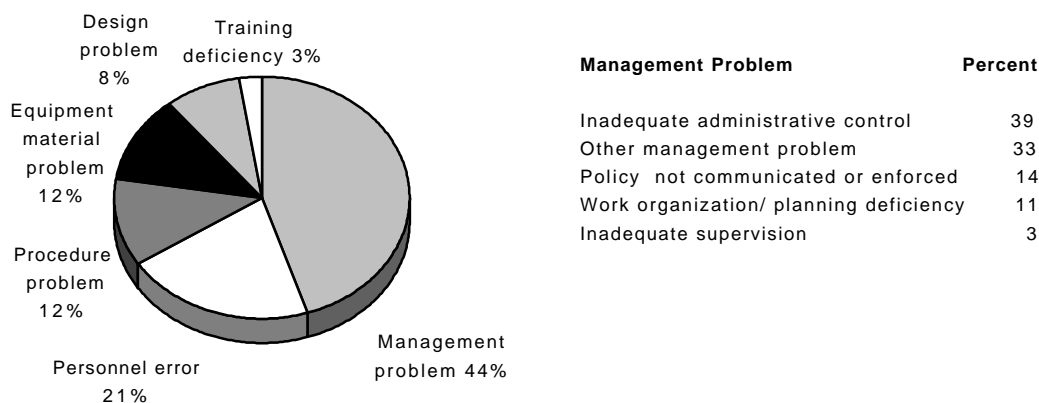
Operating Experience Analysis and Feedback (OEAF) engineers reviewed the Occurrence Reporting and Processing System (ORPS) database for radiation exposure and found 214 occurrences. Figure 3-1 shows facility managers reported management problems as the root cause for 44 percent of radiation exposure events across the DOE complex. Thirty-nine percent of the management problems were the result of inadequate administrative control. Eleven percent of the management problems were the result of work organization or planning deficiencies.

Figure 3-1. Distribution of Root Causes for Radiation Exposures Across the DOE Complex¹
